P-51D

Walk Around Number 7
squadron/signal publications

Walk Around

P-51D Mustang

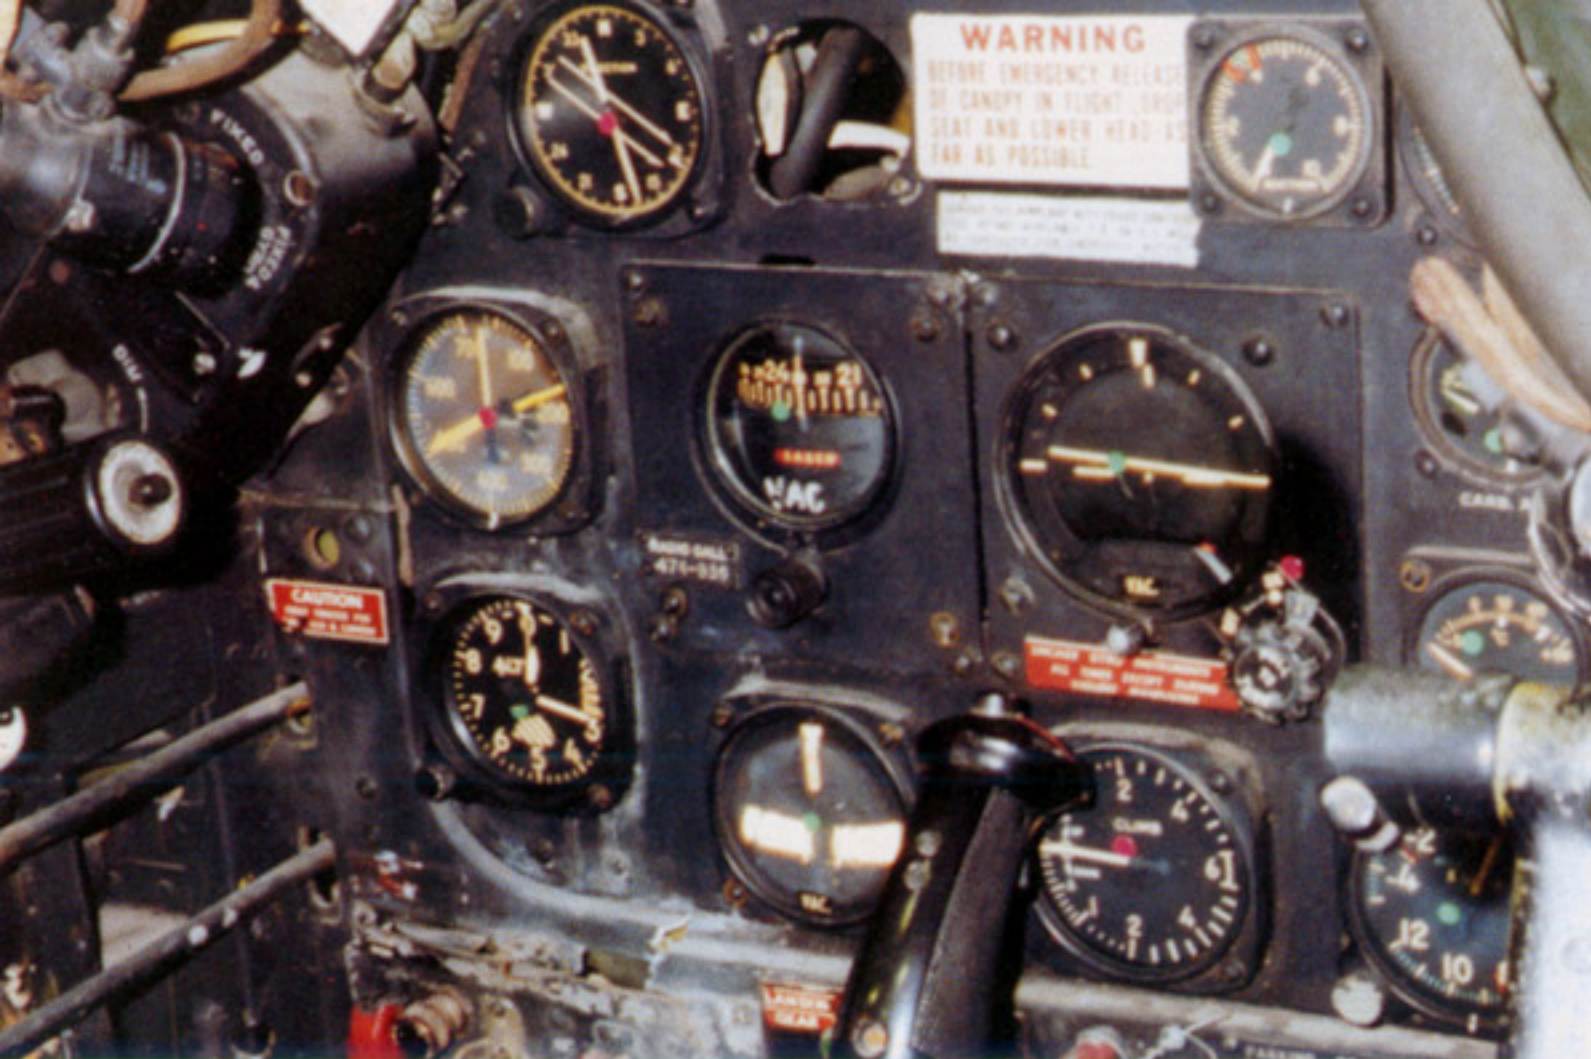
The port side of the instrument panel showing the (from upper left) compass, clock (removed), suction gauge, artificial horizon, "caged" directional gyro, RPM tachometer, altimeter, turn and bank indicator, and rate of climb gauges.

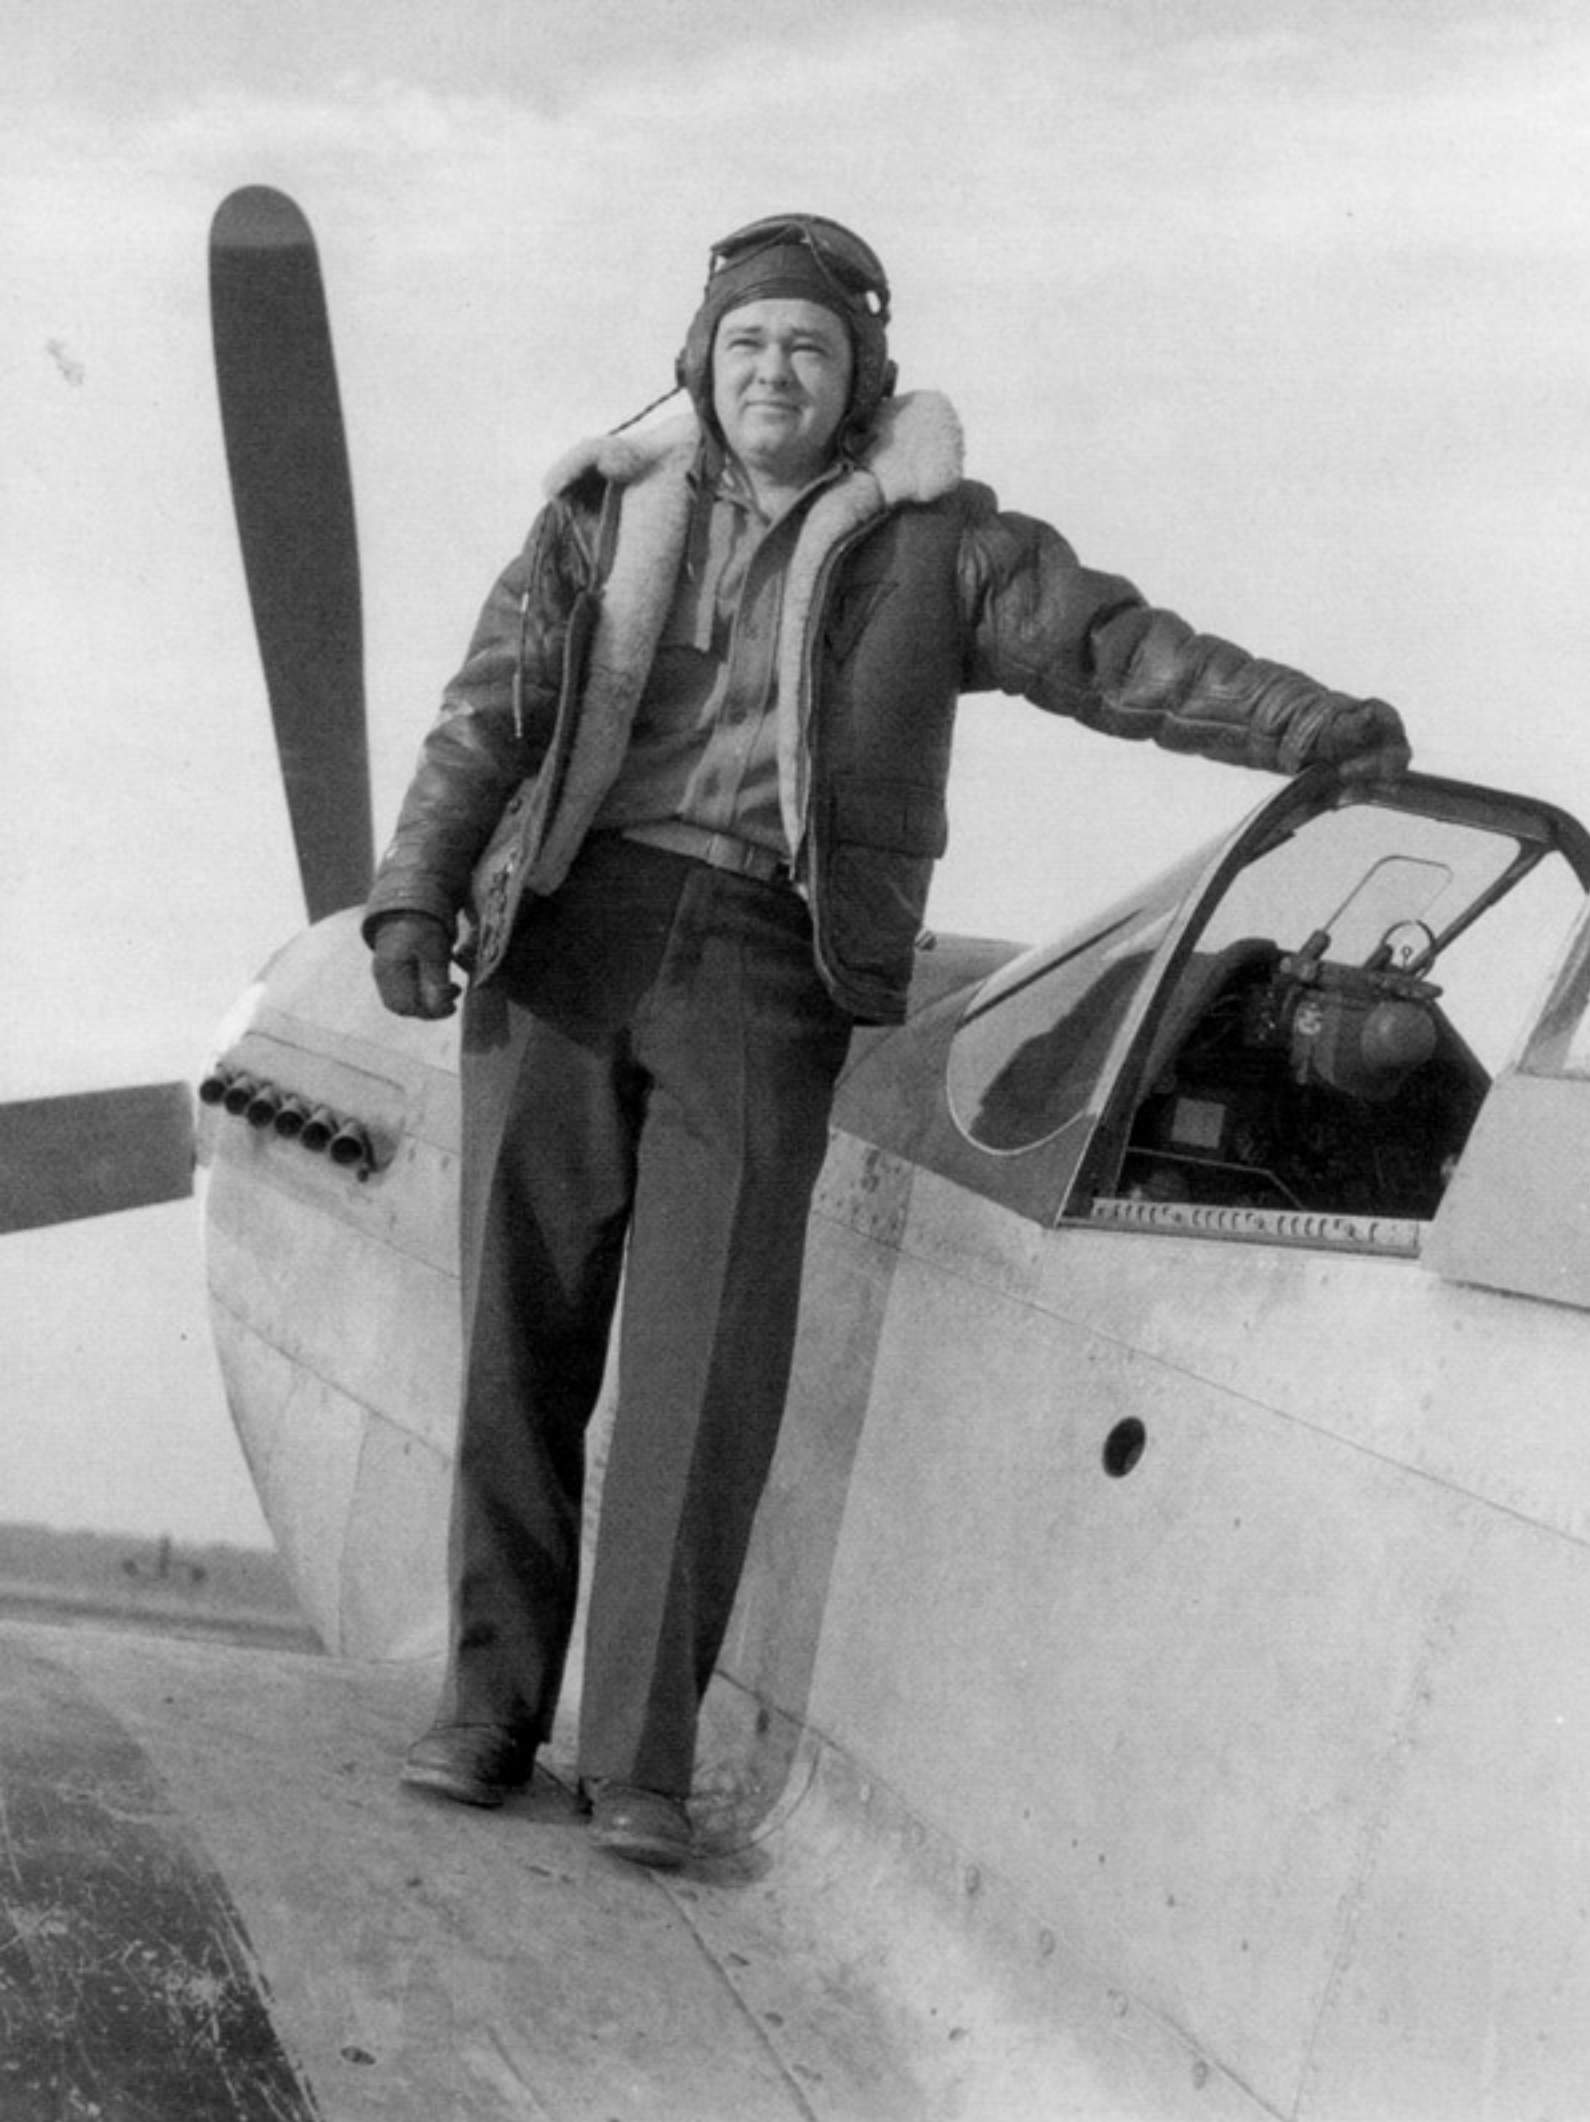
The N9 reflector gunsight is visible in the cockpit of this early P-51D. There is also a ring and bead' sight beside the N9B gunsight glass, which could be swung into place should the N9 sight malfunction. (USAAF)

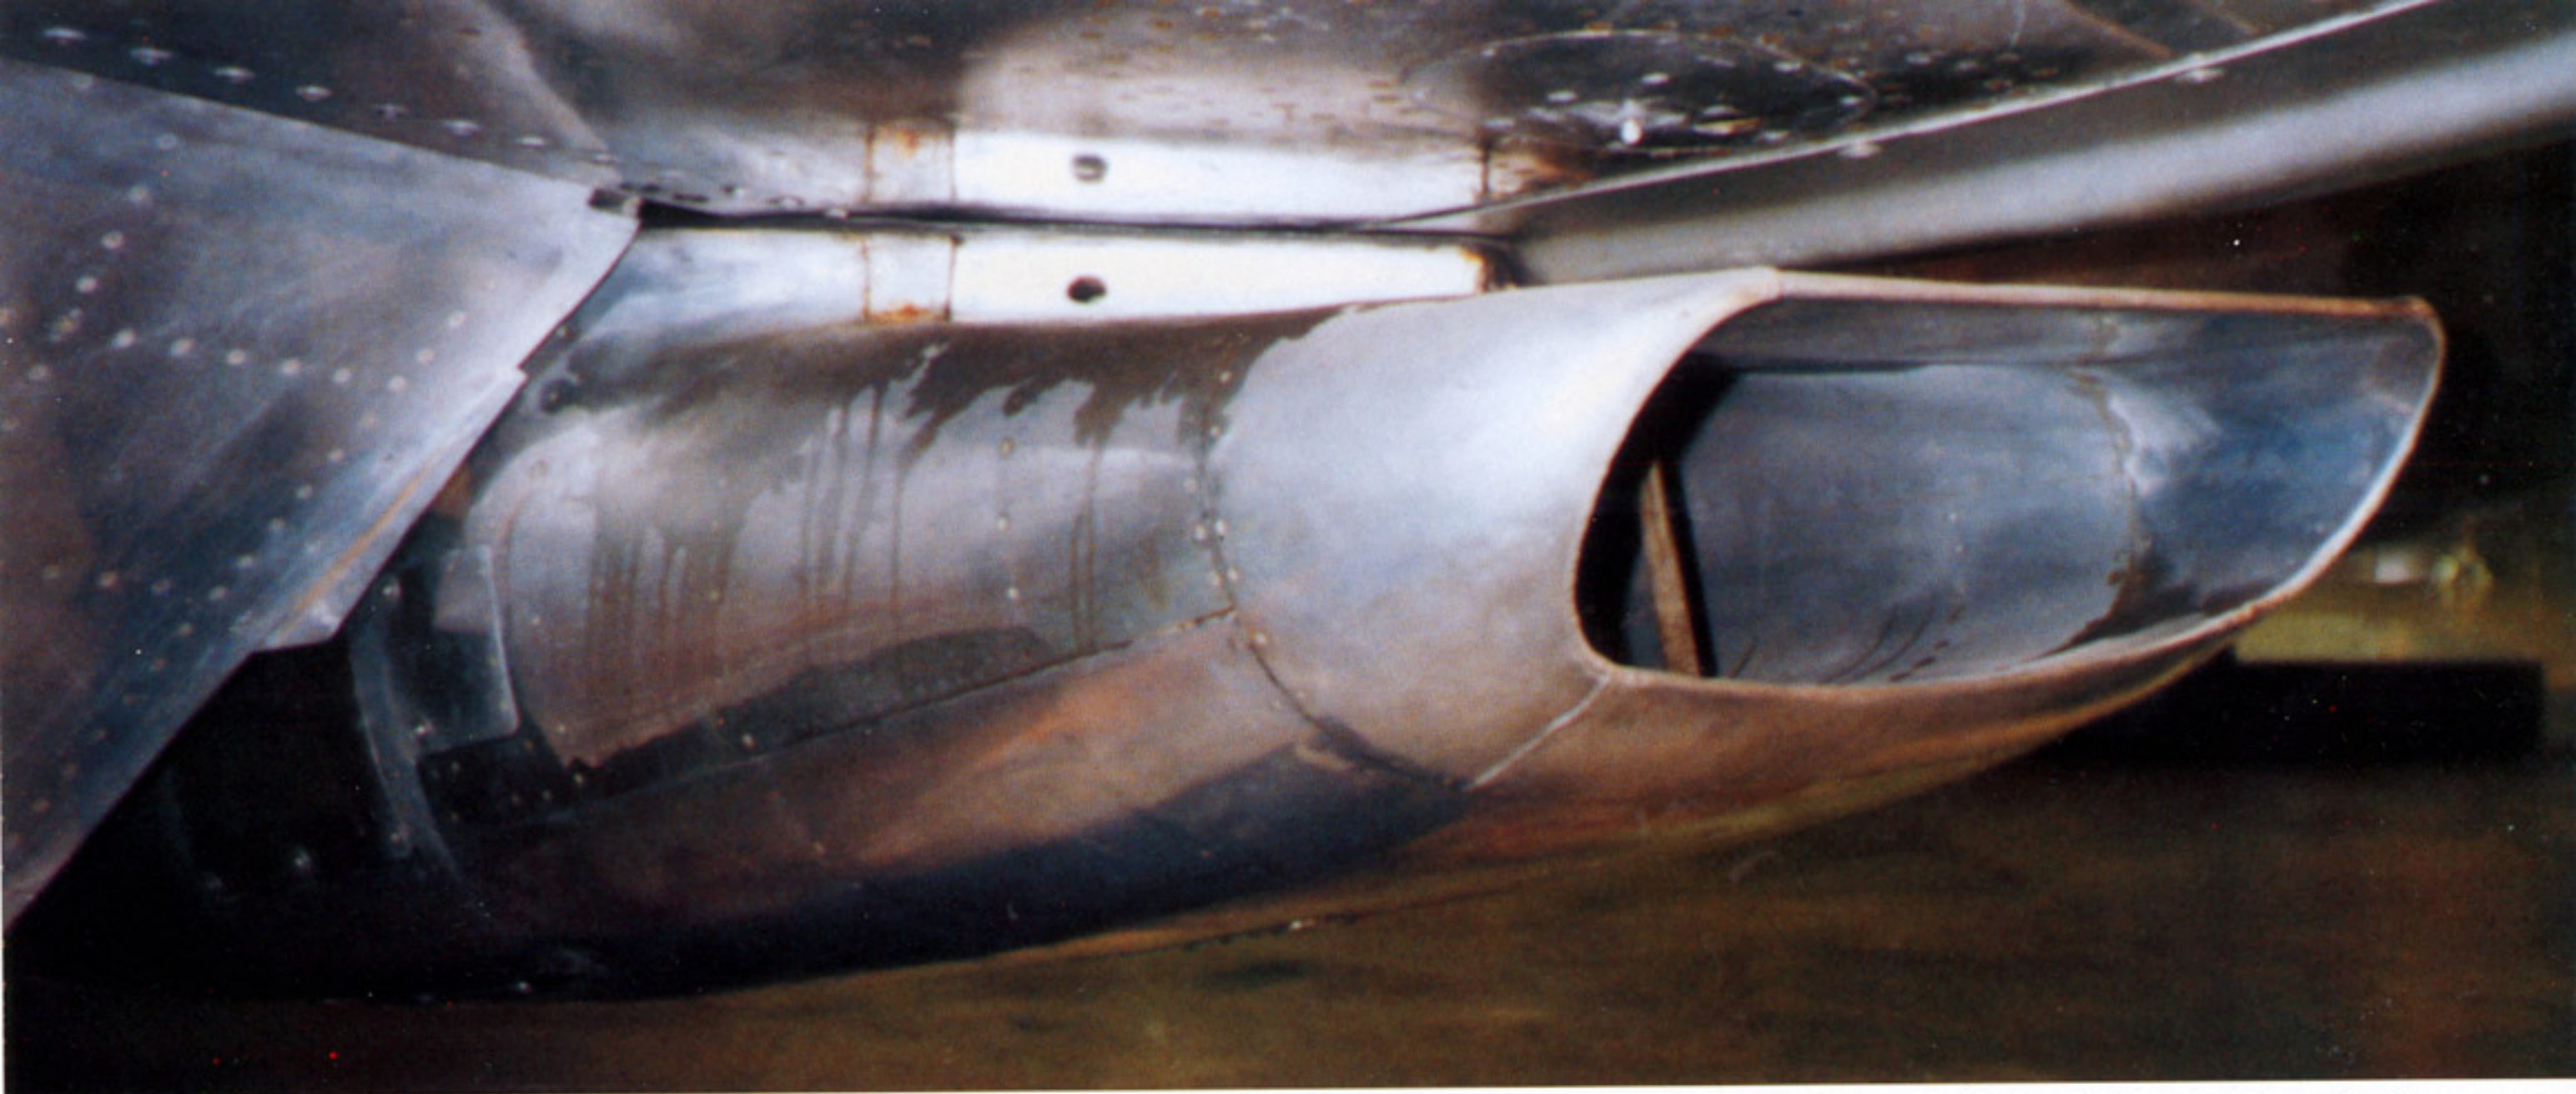
The engine/aftercooler radiator intake was distinctive and common to all the Merlin-engined P-51 series. Air was inducted through this scoop, passing through the oil cooler and radiator, then exiting through doors under the rear fuselage. There was a small reinforcement bar installed just inside the air intake duct.

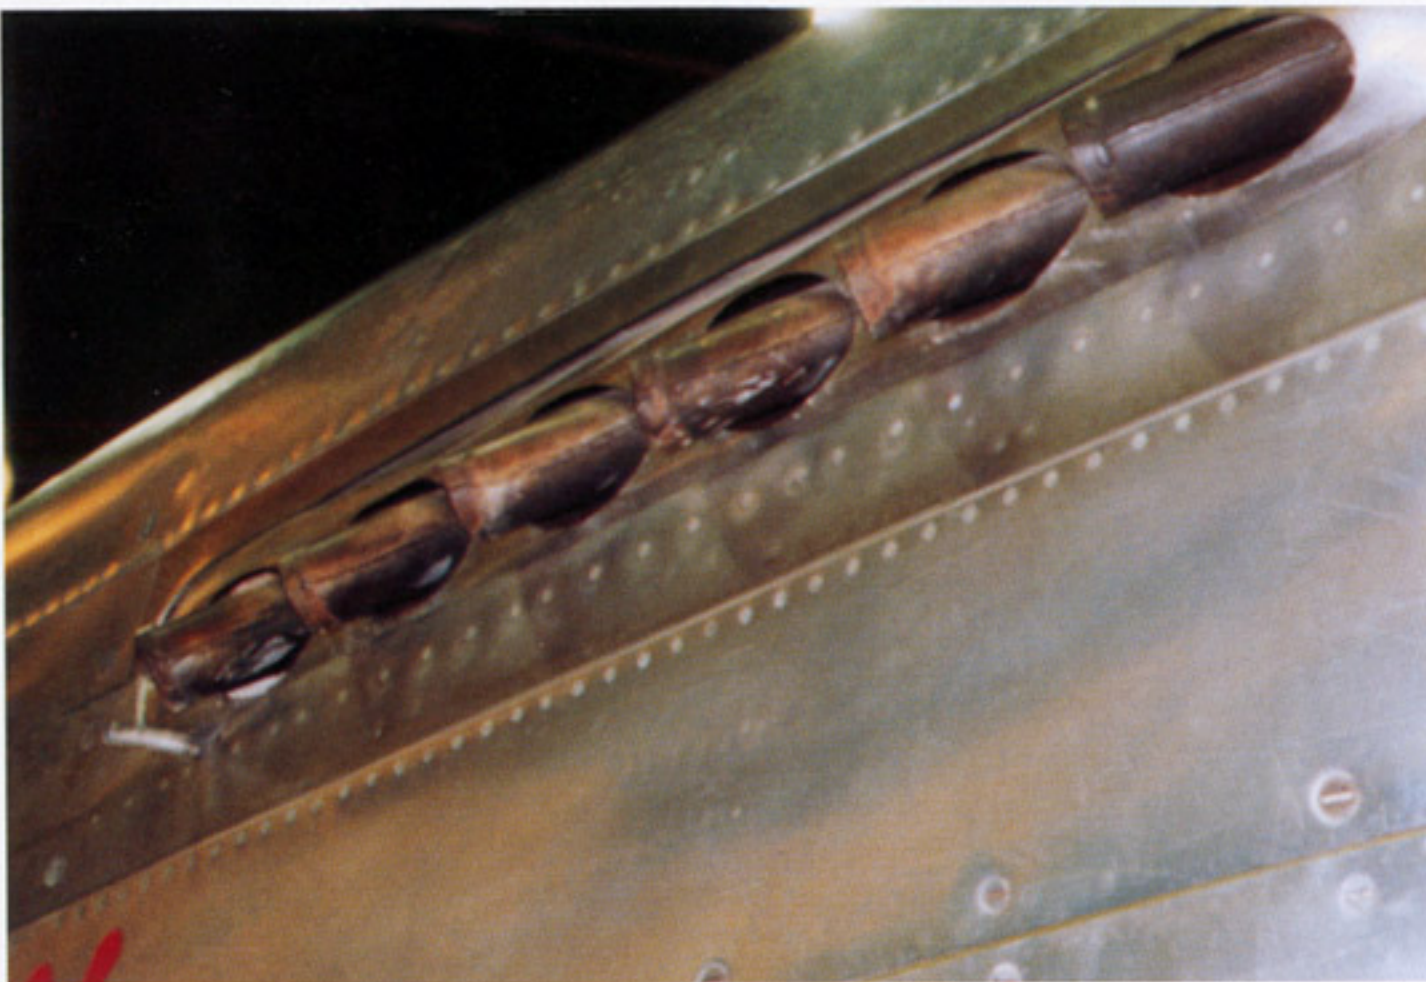
The left and right twelve cylinder Merlin engine exhaust pipes and shrouds. Each cylinder had its own individual exhaust stacks. The shrouds did a couple of things, including adding to the aerodynamics around the open exhausts, and deflecting exhaust heat from inside the engine compartment.

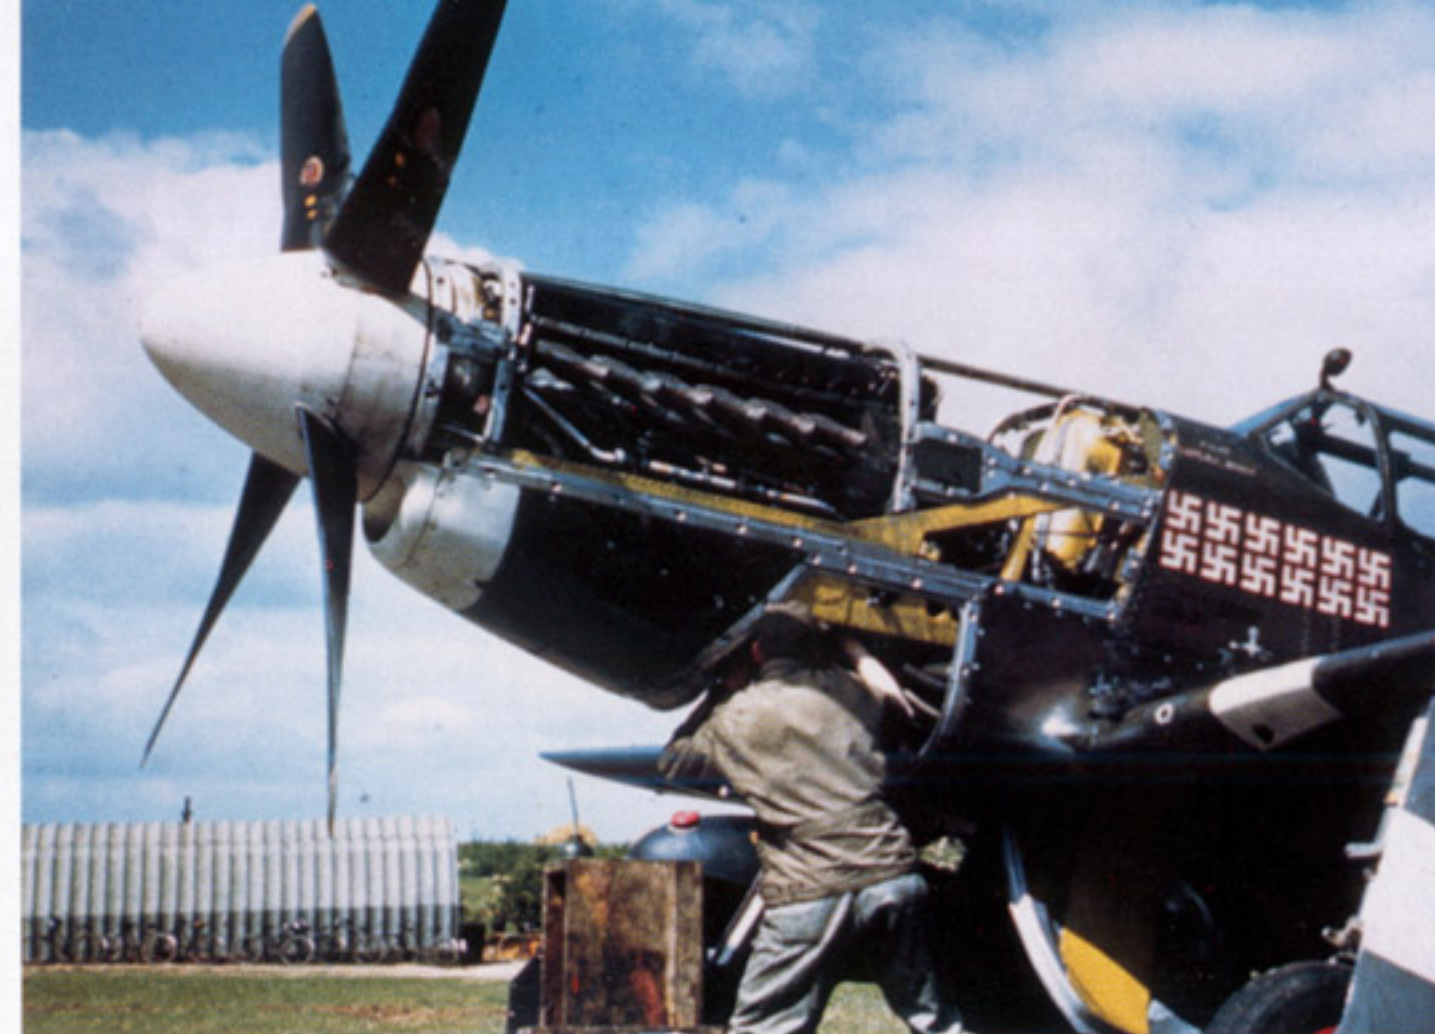
This 355th Fighter Group mechanic is adjusting the fuel pump on a P-51B at Steeple Morden. The engine installation was identical from the P-51B through P-51K, including the F-6 variants. The engine mount is painted Chromate Yellow. (355th FG Assn.)
